**Charles R. Lowman Power Plant
Leroy, AL**

CCR Impoundment Inspection Report

January 2016

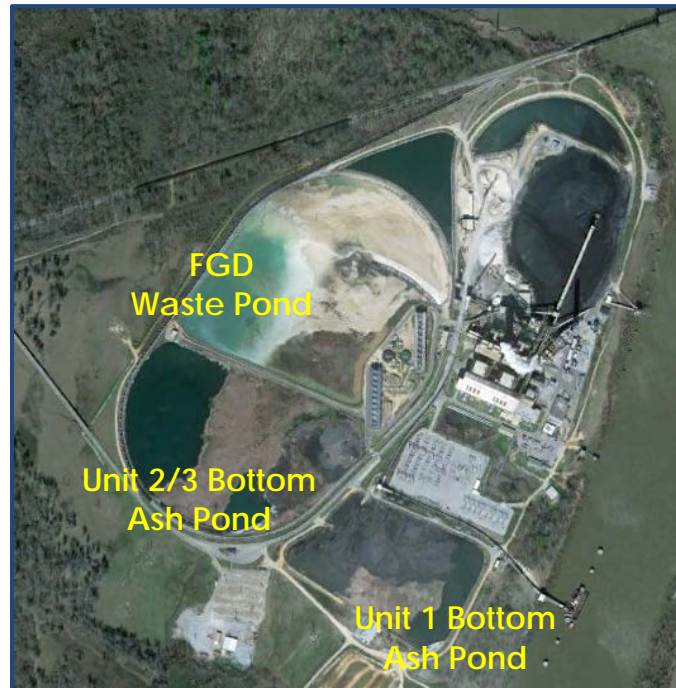
Figure 1
Identification of Ponds

The Charles R. Lowman Power Plant campus in Leroy, AL includes three impoundments for the storage of coal combustion residual (CCR) material. These are noted as shown in Figure 1.
