**Charles R. Lowman Power Plant
Leroy, AL**

CCR Impoundment Inspection Report

January 2017

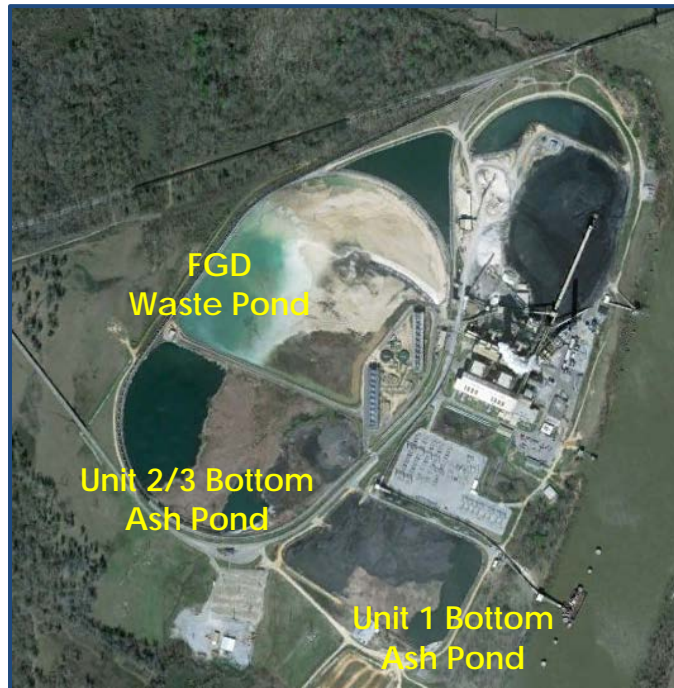
Figure 1
Identification of Ponds

The Charles R. Lowman Power Plant campus in Leroy, AL includes three impoundments for the storage of coal combustion residual (CCR) material. These are noted as shown in Figure 1.
