**Charles R. Lowman Power Plant
Leroy, AL**

CCR Impoundment Inspection Report

October 2020

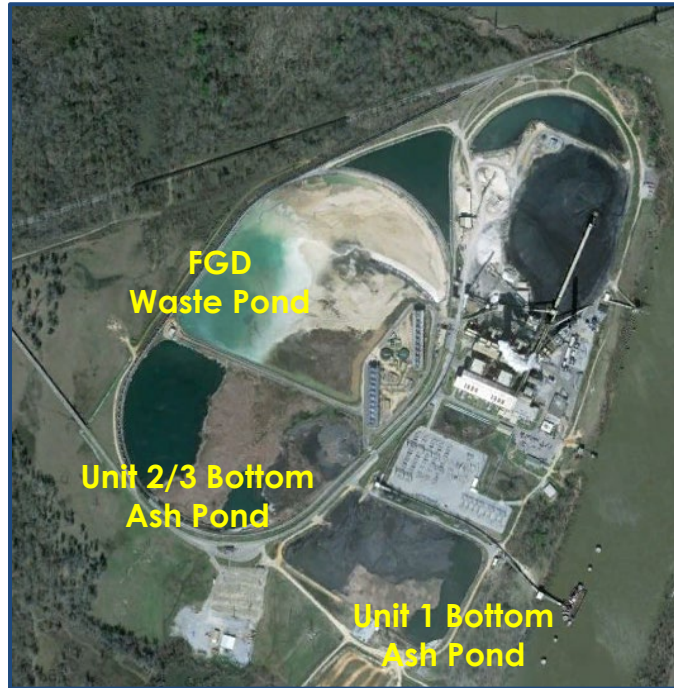
Figure 1
Identification of Ponds

The Charles R. Lowman Power Plant campus in Leroy, AL includes three impoundments for the storage of coal combustion residual (CCR) material. These are noted as shown in Figure 1.
